FINAL REPORT OF TEST

OPERATIONAL TEST II (OT II)

EMERGENCY REPAIR SHELTER

CH-47 HELICOPTER **

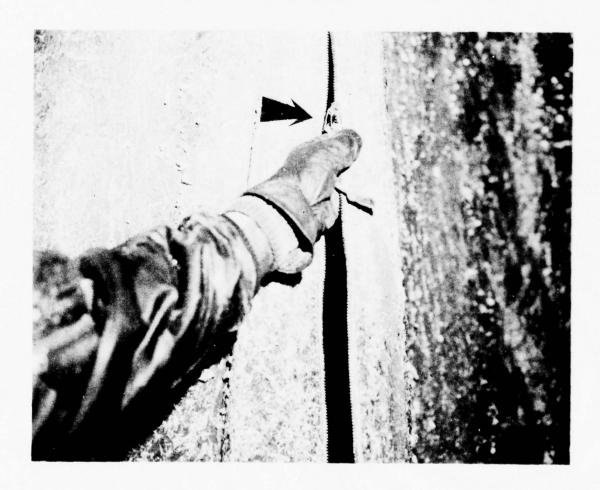
Figure 1

- (2) Freezing rain and ice accumulation on the shelter caused the zipper to come apart from the slider prior to the modification. (Para 2.4.1.3.2,c)
- e. <u>Transportability</u>. Objectives were met. The shelter was satisfactorily transported by 3/4 ton and $2\frac{1}{2}$ ton cargo trucks, and internally and externally by UH-1 helicopter. (Para 2.4.1.4.3,a).

- c. The zipper on the intermediate shelter wall containing the APU and heater sleeves came apart above the slider (Appendix I, Fig 1). This damage occurred at $0^{\circ}F$ and after the frezzing rain test (5 hours) which included approximately 1/4 inch ice accumulation on the shelter. The zippers on the other three shelter walls either pulled out or came apart above the slider when erecting the same shelter at $-65^{\circ}F$.
- d. After 12 erecting/striking cycles, all rib frames were bent at the top and bottom points where they attach to the center pole. One top attachment rib frame was broken (Appendix I, Fig 2). This necessitated the frame to be modified for additional strength.
- e. There was no damage due to hydraulic fluid, fuel, grease, or oil leakages on the shelter.

ZIPPER FAILURE ON ICE FROZEN SHELTER

- (1) The zippers in the intermediate shelter wall were damaged after the freezing rain test; this was considered a deficiency because the shelter could not be closed and would not retain heat. The modified shelter had a flap cover over the zipper to help prevent water from entering the zipper and freezing; however, the modified shelter was not tested in freezing rain. (Para 2.4.1.1.)

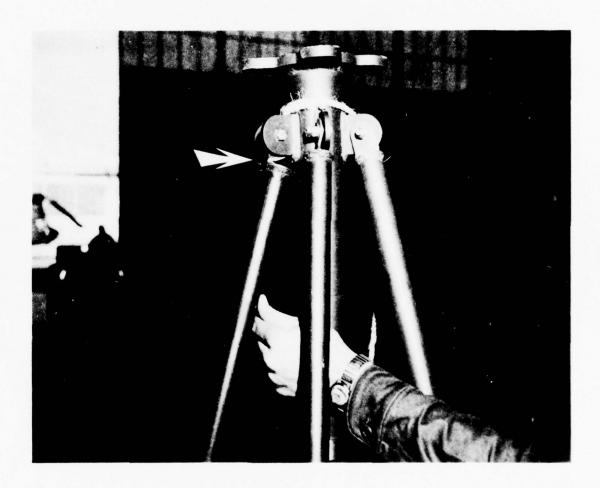
- (2) After 12 erecting/striking cycles, all the rib frames in the top shelter section were bent at top and bottom attachment points. One top attachment rib frame was broken. This was considered a shortcoming. U.S. Army Natick Laboratory modified the rib frame. However, only four cycles were accomplished prior to test completion. Therefore, the durability of the modified rib frame was not determined. (Para 2.4.1.1.3,d).

All rib frames were bent at the top and bottom points where they attach to the center pole. One top attachment point was broken.

SHELTER TOP RIB FRAME BROKEN ATTACHMENT POINT

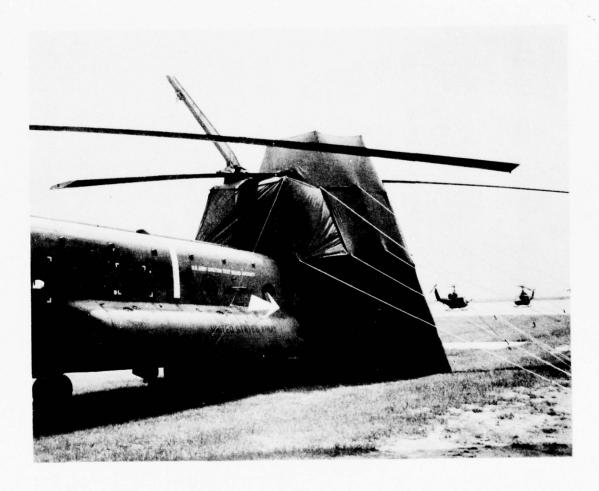
CLOSE FIT OF SHELTER TO AIRFRAME

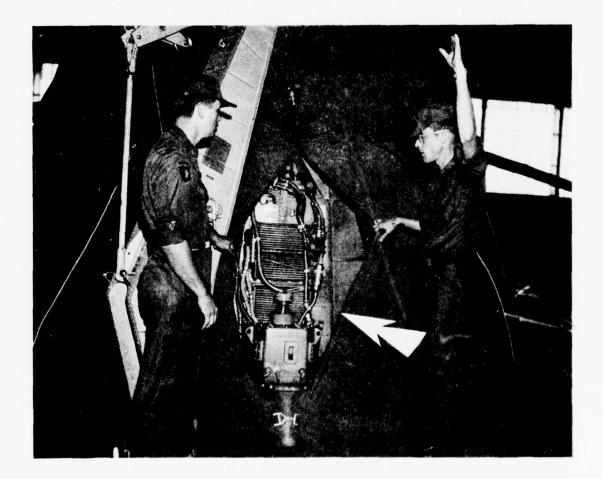
- a. The shelter provided the specified 4-foot clearance above the rotor head. However, when the shelter was erected over the aft rotor, the following restrictions were noted where the shelter covered the combining transmission and engine transmission areas:
- (1) Entrance to the shelter in the vicinity of the combining transmission was restricted, especially for personnel wearing arctic clothing (Appendix I, Fig 4).
- (2) The pylon leading edge hinge fairings struck the shelter walls when opening.
- (3) Inadequate workspace and protection were provided to mechanics performing maintenance in the following areas:
 - a. Combining transmission
 - b. Oil coolers

UNMODIFIED AFT SHELTER AT MIDCASE AREA

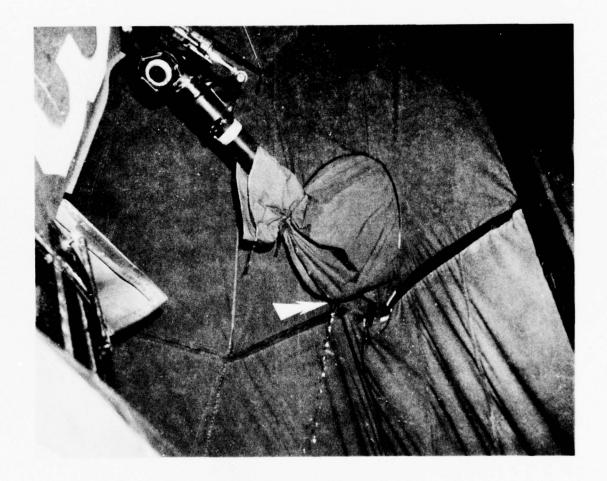
Figure 5

- a. The shelter fabric was lightweight, water-resistant, and wind-resistant. During the rain test, water leaked around the zipper seams, but did not leak into the work area. After modification (i.e., incorporation of flaps over the zippers), no leakage was noted around the zippers during a 1/2 inch rainfall. The top shelter section tore under heavy wind at the shelter frame to fabric attachment point along the seam area. (Appendix I, Fig 11).
- b. Fabric stress areas such as guy rope tiedown attachment points were provided with reinforcements. These reinforcements were durable during winds up to 40 knots.

WATER LEAK AROUND BLADE OPENINGS

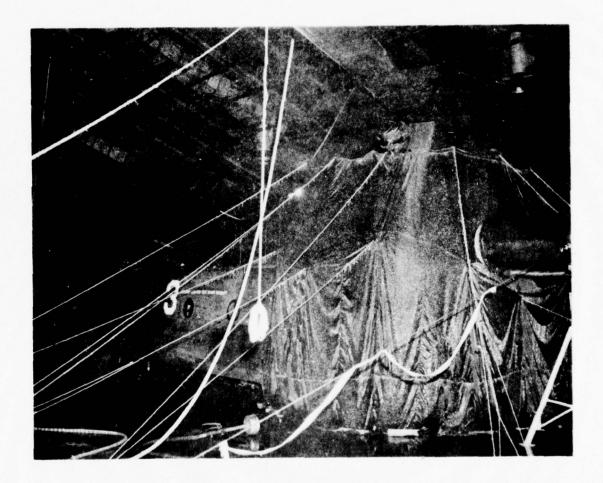
ICE TEST OF FRONT AND REAR SHELTERS
Figure 6

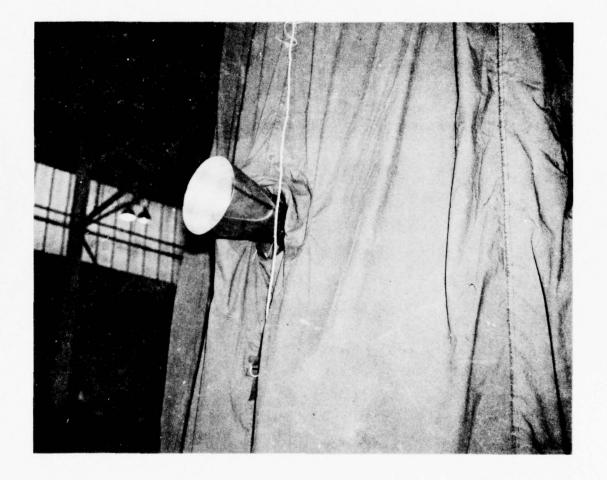
APU EXHAUST THROUGH AFT TENT WALL

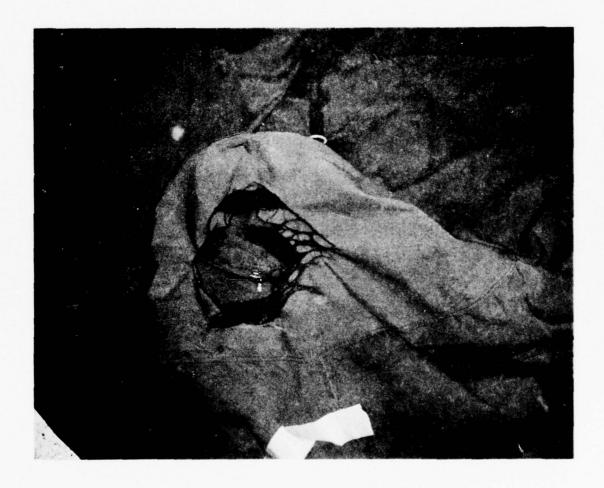
h. The shelter material around the APU exhaust charred and melted but did not burn. This area was modified with nonflammable heat resistant material around the APU exhaust vent (Appendix I, Fig 8).

CHARRED CANVAS AROUND APU EXHAUST

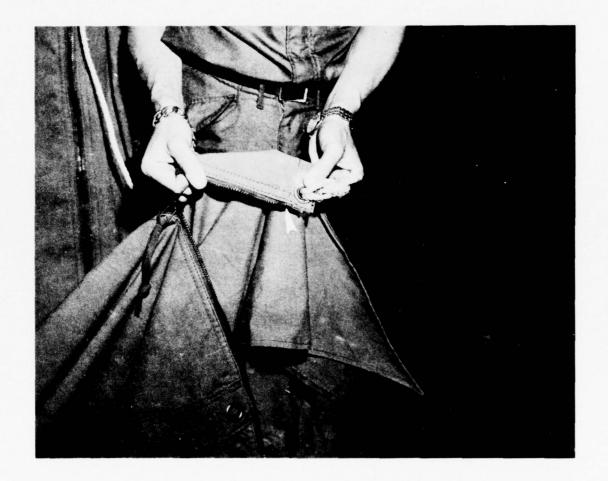
I Photo

- a. A total of 2,199 hours was accumulated with the shelter in the erected state.
- b. A total of 59 missions were attempted during the test, and two mission failures occurred. The first failure occurred at 102 cumulative erected hours. The zipper on the intermediate shelter wall which contained the APU and heater sleeves came apart during shelter striking at an ambient temperature of $0^{\circ}F$. This occurred after a freezing rain test of 5 hours duration during which approximately 1/4 inch of ice accumulated on the shelter. The entire rear wall of the shelter was replaced due to the broken zipper. (Appendix I, Fig 9).

CANVAS ZIPPER FAILURES

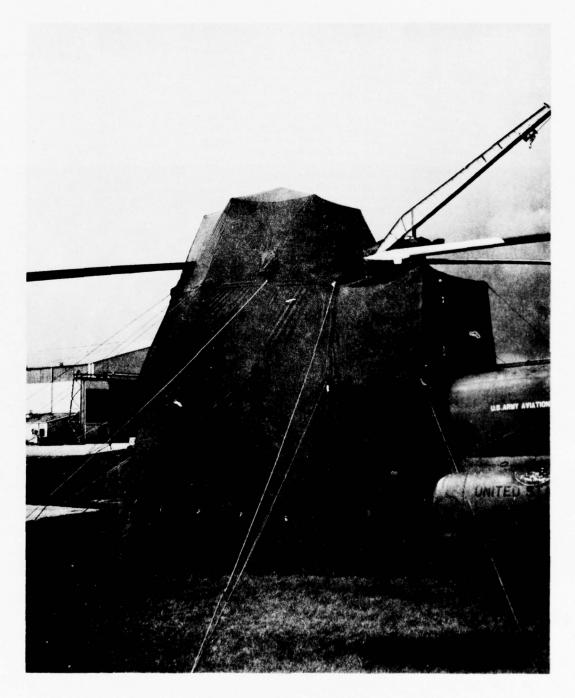
Figure 10

MODIFIED REAR SHELTER

- (2) Shelter modifications corrected the problem areas found during early test stage. The vent opening for the external heat source was enlarged to accept the external heater, the ties straps were lengthened to secure the vent to the heater, and placard was stenciled on the APU exhaust cone clamp to reduce the possibility of incorrect installation.

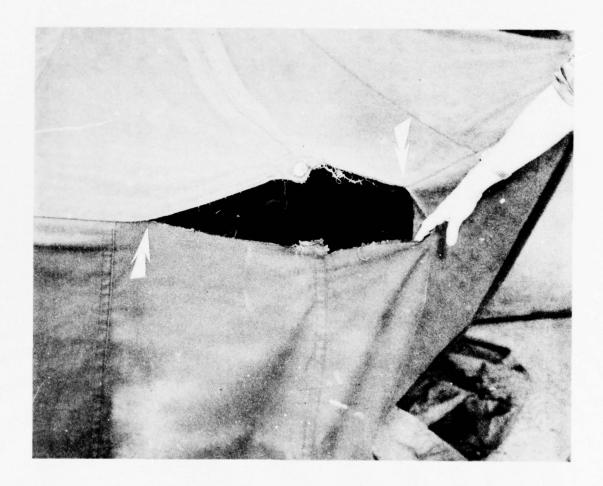
SHELTER TOP FRAME CANVAS RIPPED AT SEAM
